**Automated Vehicles and the Readiness of Western
Australian roads
RR 18-03**

**CURTIN-MONASH
ACCIDENT RESEARCH CENTRE
Faculty of Health Sciences
Curtin University
Kent Street
Bentley WA 6102**

Mackenzie, J., Dutschke, J., van den Berg, A., Kumar, M., Meuleners, L.
June 2018

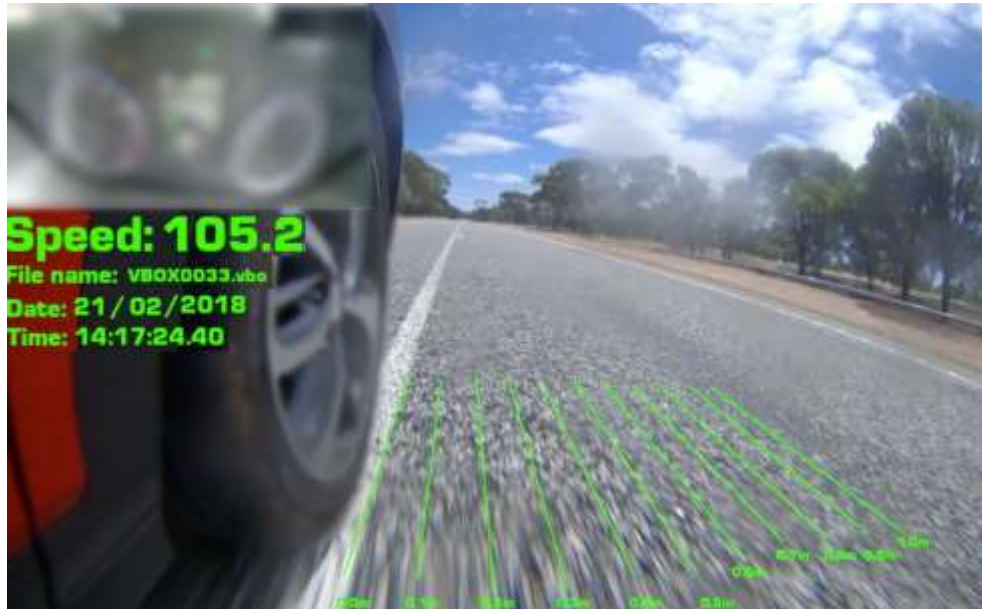
Figure 2.1 Camera layout used to record line crossing events

For this study, the two cameras were positioned to capture images of the vehicle instrument panel, where the lane departure warnings would appear, and either the left or right front wheel, such that a line crossing event could be observed. An image of this camera layout can be seen in Figure 2.1. Also note the graphical overlay, in bright green, which shows details of the current vehicle speed, date, time, and filename, along with calibrated lines which display the lateral distance from the edge of the wheel.

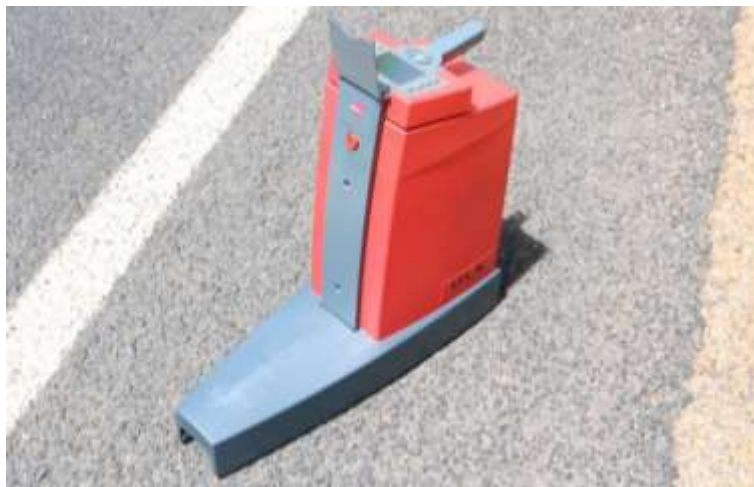
Figure 2.3 The LTL-X Retroreflectometer

A Delta LTL-X retroreflectometer (shown in Figure 2.3) was used to measure the retro-reflectivity of the line markings at the trial sites. The retroreflectometer operates by projecting a light source towards the line marking at an angle of 1.24° and then measuring the amount of light reflected at an angle of 2.29° . This provided a measure of the brightness of the line marking in car headlight illumination as seen by a driver at an observation distance of 30 meters. The retro-reflectivity is measured in units of milli-candelas per lux per square metre (mcd/lx/m^2).

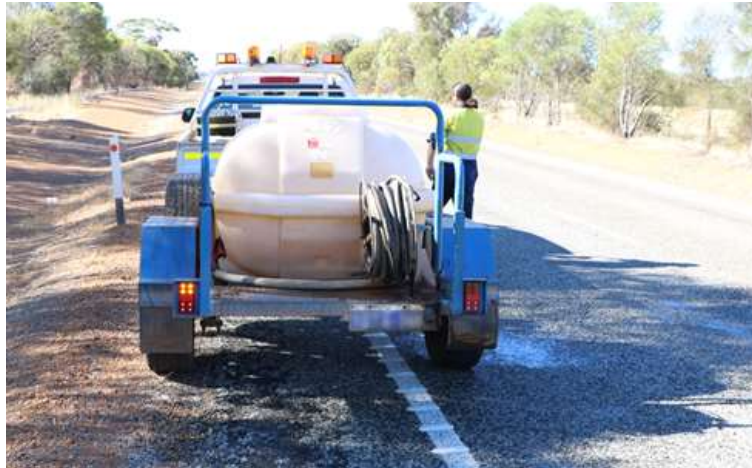
Figure 2.4 Water truck

A water truck (shown in Figure 2.4) was utilised to provide a ‘wet line’ along the road at two of the rural trial sites. Water was sprayed through a hose onto the road as the water truck travelled along. The water truck was provided and operated by the local regional council in the relevant areas.

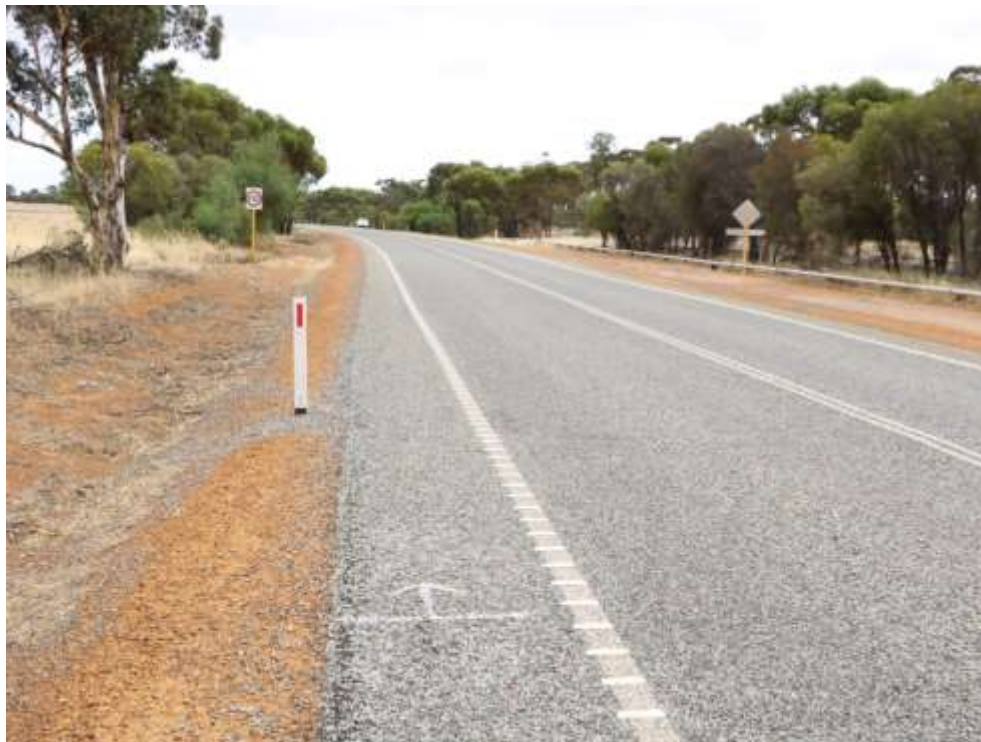
Figure 2.6 Site P1, Great Southern Highway (SLK 108-109)

Site P1 is located on the Great Southern Highway between SLK values of 108 and 109. The site has a double barrier centreline and audio-tactile edge lines. Only the centre line was subjected to testing. A photograph of the site is shown in Figure 2.6 and the dimensions of the road are shown in Table 2.2. Retro-reflectivity was measured at two locations at this site and the average of these measurements is shown in Table 2.3.

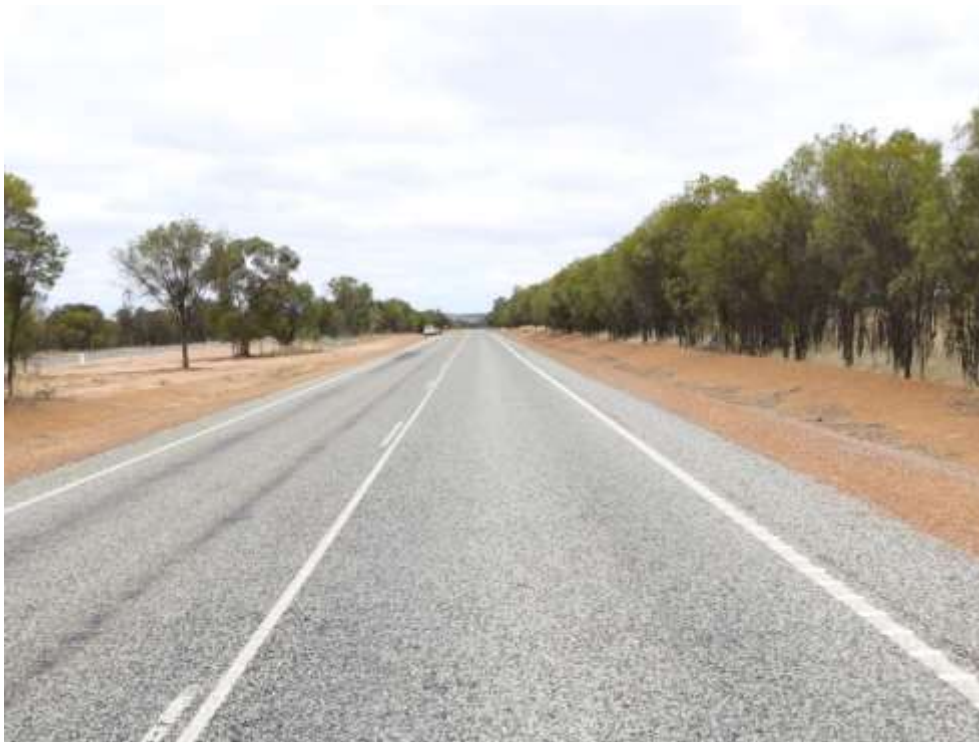
Figure 2.7 Site P2, Great Southern Highway (SLK 109-110)

Site P2 is located on the Great Southern Highway between SLK values of 109 and 110. The site has a broken-barrier centreline line type and audio-tactile edge lines. The barrier-broken is found in a Northbound direction and the broken-barrier type line is found in a Southbound direction. Only the centre line was subjected to testing. A photograph of the site is shown in Figure 2.7 and the dimensions of the road are shown in Table 2.4. Retro-reflectivity was measured at two locations at this site and the average of these measurements is shown in Table 2.5.

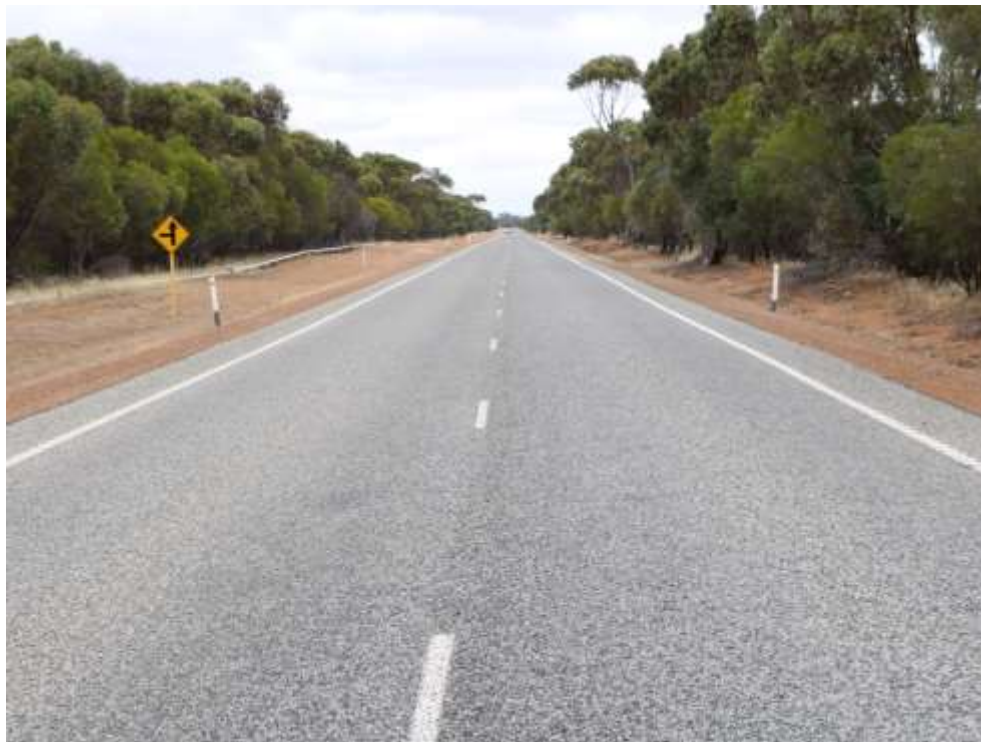
Figure 2.8 **Site P3, Great Southern Highway (SLK 111-112)**

Site P3 is located on the Great Southern Highway between SLK values of 111 and 112. The site has a broken centreline and audio-tactile edge lines. Both the centreline and edge lines were subjected to testing. A photograph of the site is shown in Figure 2.8 and the dimensions of the road are shown in Table 2.6. Retro-reflectivity was measured at two locations at this site and the average of these measurements is shown in Table 2.7.

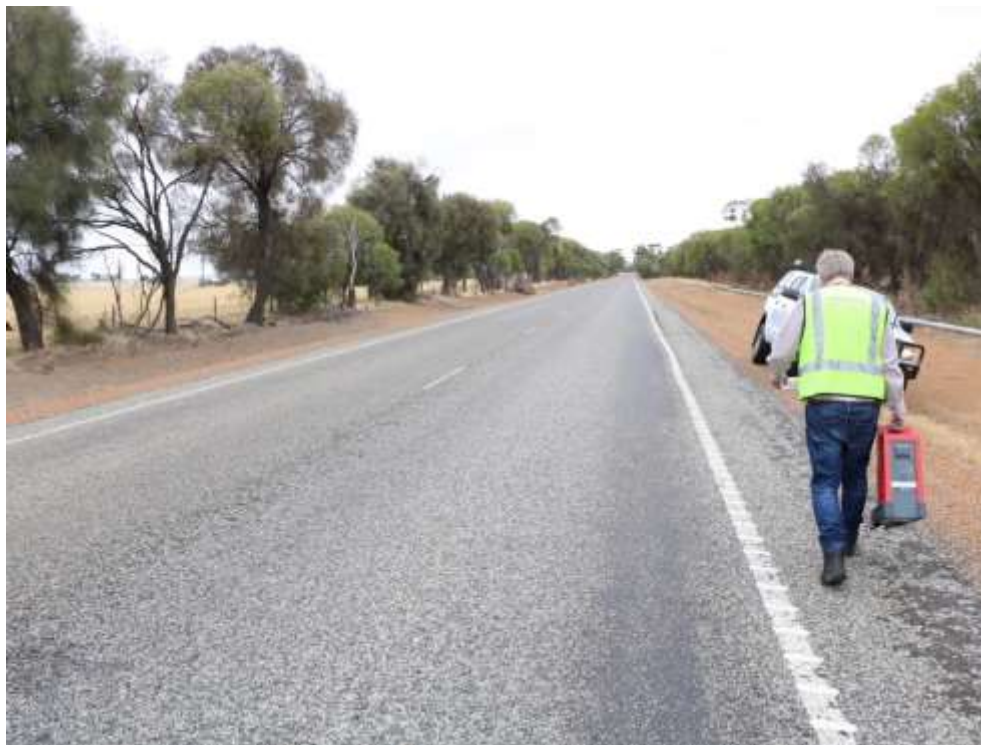
Figure 2.9 Site P4, Great Southern Highway (SLK 113-118)

Site P4 is located on the Great Southern Highway between SLK values of 113 and 118. The site has a broken centreline and audio-tactile edge lines. Only the centre line was subjected to testing. A photograph of the site is shown in Figure 2.9 and the dimensions of the road are shown in Table 2.8. Retro-reflectivity was measured at one location at this site and is shown in Table 2.9. The low retro-reflectivity in the Northbound direction was suggested by the experts from Main Roads to be the result of the marking being painted too fast, or a paint-gun not being configured correctly.

Three warning failures occurred on the centreline at site P4; two in the Northbound direction where the retro-reflectivity was 57 mcd/lx/m² and one in the Southbound direction where the retro-reflectivity was 137 mcd/lx/m². It is important to note that these failures occurred while the level of daylight brightness was also low.

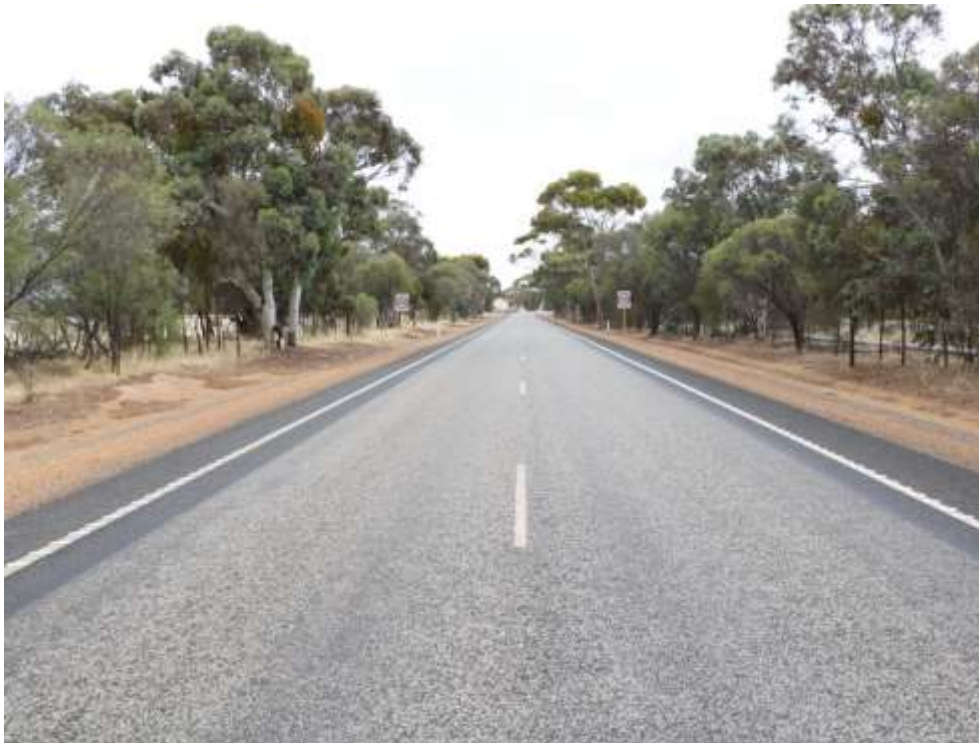
Figure 2.10 Site P5, Great Southern Highway (SLK 133-134)

Site P5 is located on the Great Southern Highway between SLK values of 133 and 134. The site has a broken centreline and audio-tactile edge lines over a darkened bitumen shoulder. Only the edge lines were subjected to testing. A photograph of the site is shown in Figure 2.10 and the dimensions of the road are shown in Table 2.10. Retro-reflectivity was measured at one location at this site and is shown in Table 2.11.

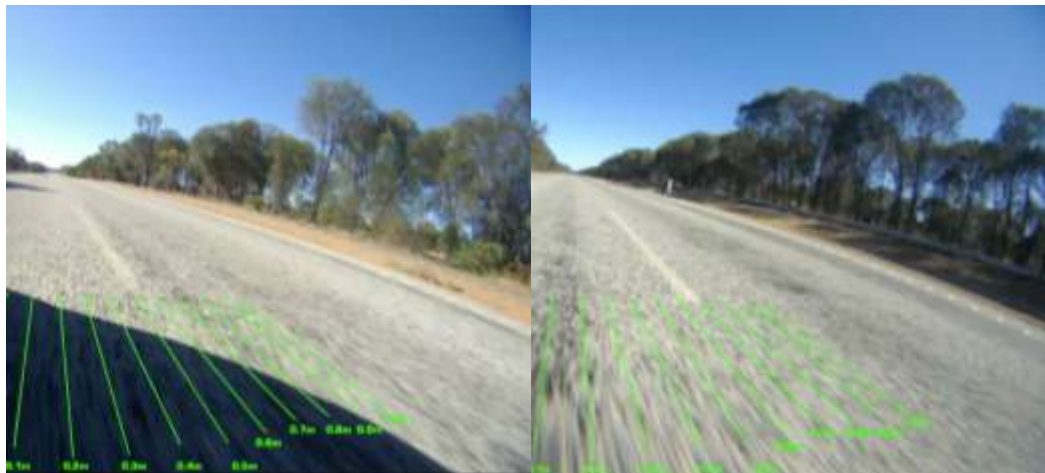
Only the centreline was subjected to testing. A still taken from the recorded video data is shown in Figure 2.11. No site dimensions were recorded, and retro-reflectivity was not measured.

Figure 2.11 Recorded images of centrelines at Site A1 showing Northbound (left) and Southbound (right) travel

It is also worth noting that the remaining two warning failures on centrelines, where the retro-reflectivity was not measured, occurred at site A1 whilst travelling in a Northbound direction where the field-work team found it difficult to see the line.

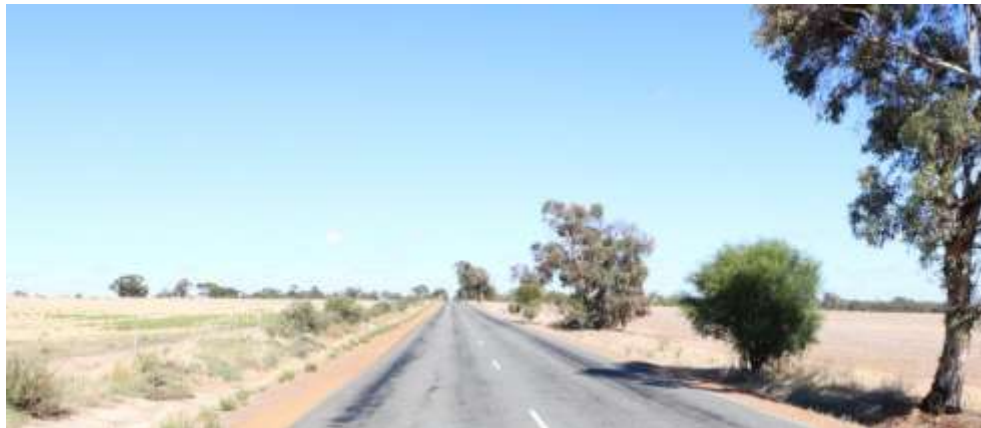
Figure 2.12 Site A2, Wickepen-Pingelly Road

Site A2 is located on Wickepen-Pingelly road, immediately East of the township of Pingelly. The site has a broken centreline and is without edge lines.

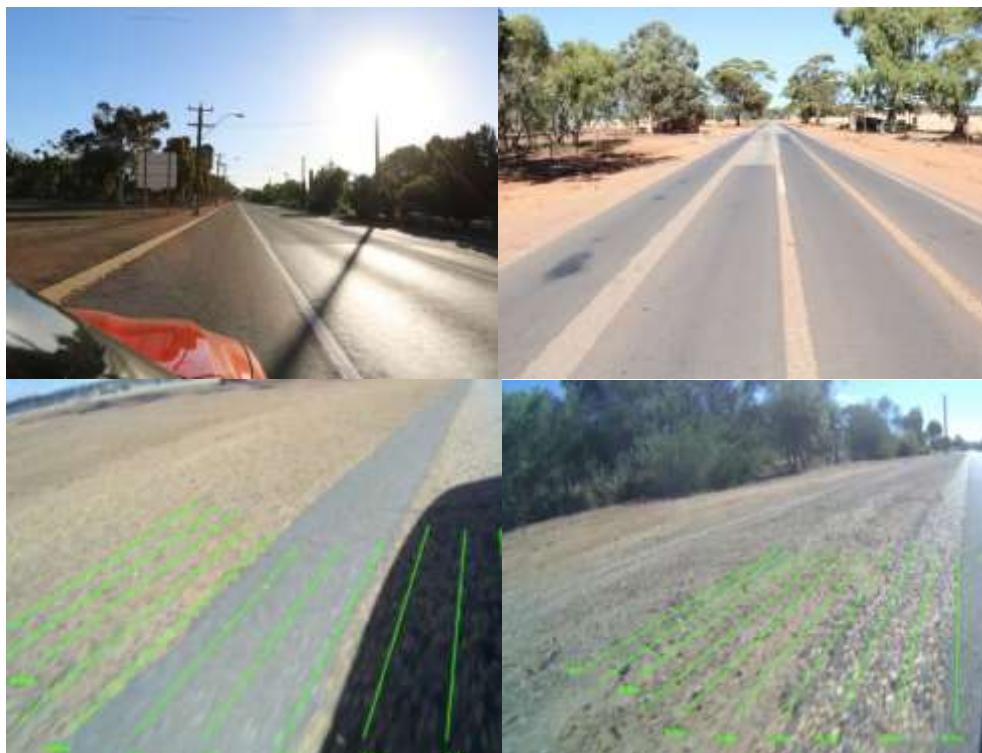
Site A3 is located on the Brookton Highway, immediately West of the township of Brookton. The site has a length of approximately six kilometres and includes sections of road within the Brookton township. The site has many varied road markings as shown in Figure 2.13.

Figure 2.13 Recorded images at Site A3 showing edge lines in the town centre (top left); pseudo edge lines (top right); dark bitumen shoulder (bottom left); and light bitumen shoulder (bottom right)

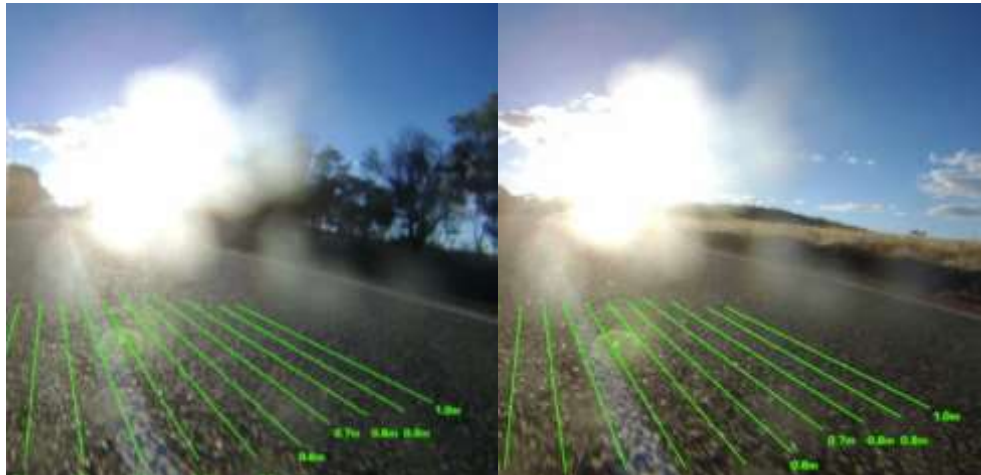
tested during these times of sun glare. Screen shots from the sun glare situations are shown in Figure 2.14.

Figure 2.14 Sun glare on a broken barrier type line (left) and broken centreline (right) at Site A3

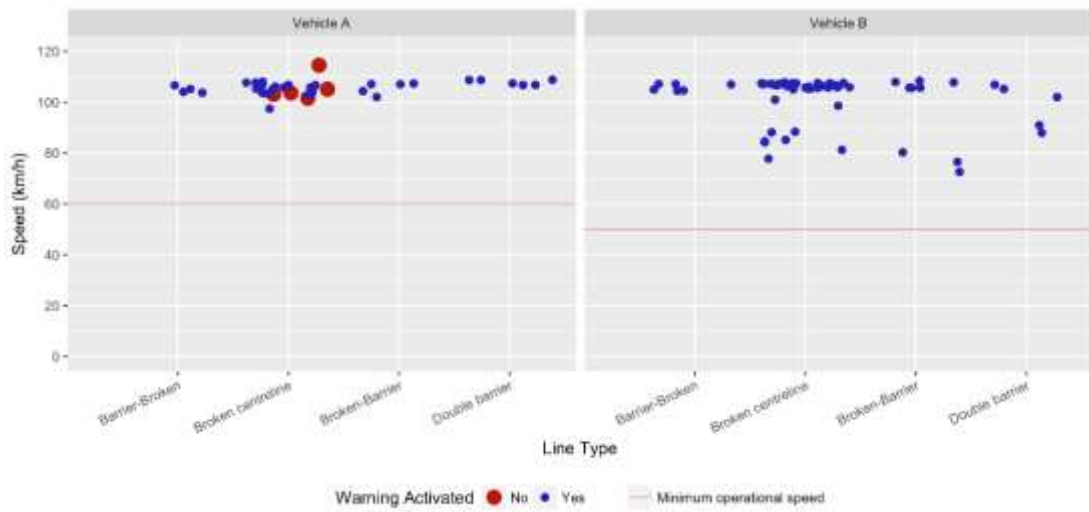
For the centreline data, the crossing event travel speeds ranged between 70 km/h and 110 km/h. The five warning failures occurred at speeds between 100 km/h and 110 km/h. The travel speed did not appear to have any effect on the ability of the LDW system to correctly identify the line marking.

Figure 3.1 Crossing event travel speeds for marked centrelines

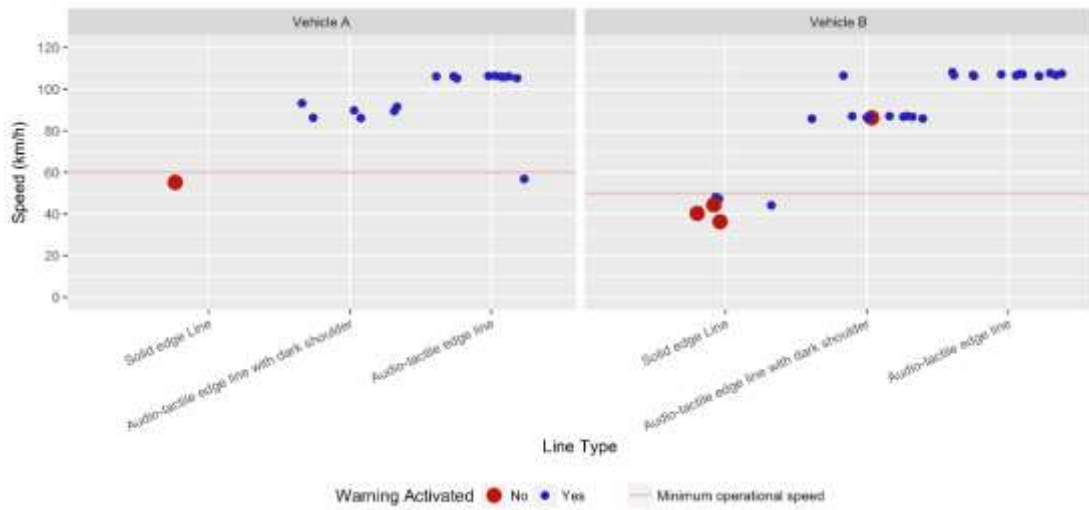
For the marked edge lines, the speeds ranged between 30 km/h and 110 km/h. Five of the warning failures occurred at speeds below the manufacturer's advised minimum speed for system operation. A specific reason for the one warning failure that occurred at a speed above the manufacturer's advised minimum speed could not be identified.

Figure 3.2 Crossing event travel speeds for marked edge lines

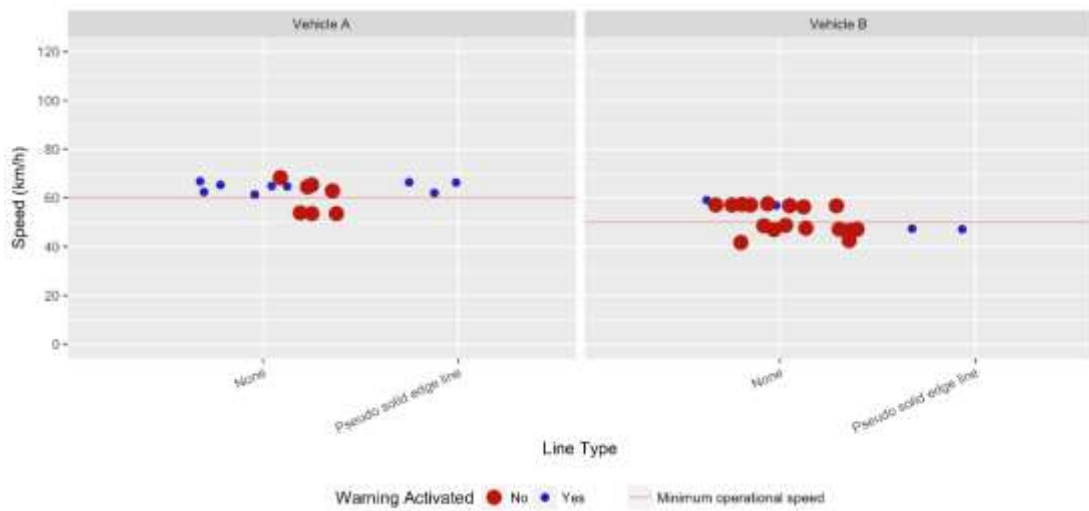
For the unmarked road edge data, the speeds ranged between 40km/h and 85 km/h. Warning failures occurred both above and below the minimum recommended speed. The majority of successful warnings occurred at speeds above the minimum recommended speed,

Figure 3.3 Crossing event travel speeds for unmarked road edges
